ProTechnology

COMPLETION DIAGNOSTICS NEWS FROM PROTECHNICS

SHINING A LIGHT ON FRAC PERFORMANCE IT'S WHAT YOU KNOW THAT COUNTS

A COAL STORY

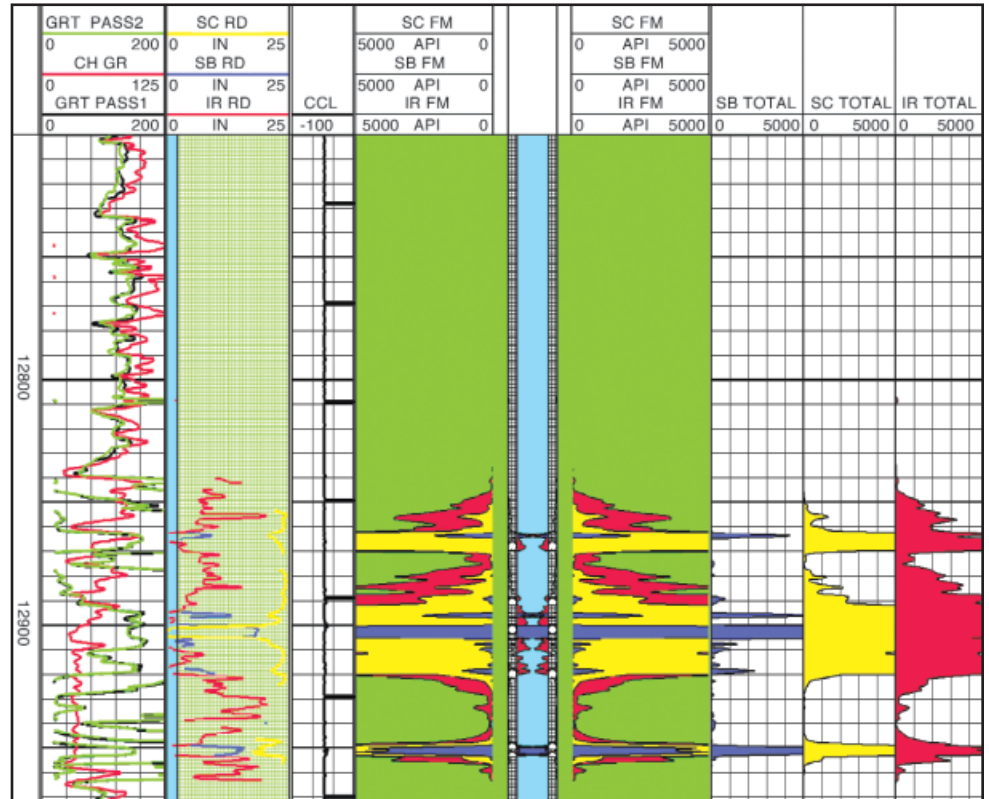
IMAGE 1

After a four hour shut-in period, the operator began flowing the well back. Everything seemed fine with good gas shows and rates. After four days of flowback, a SpectraScan® memory logging tool was run from 12,650' to 13,070'. SpectraScan image 1 shows that all 3 isotopes were present in the zone of interest. The log analyst noted that there was not as high a count rate for the Sb-124, blue tracer, as should be expected.

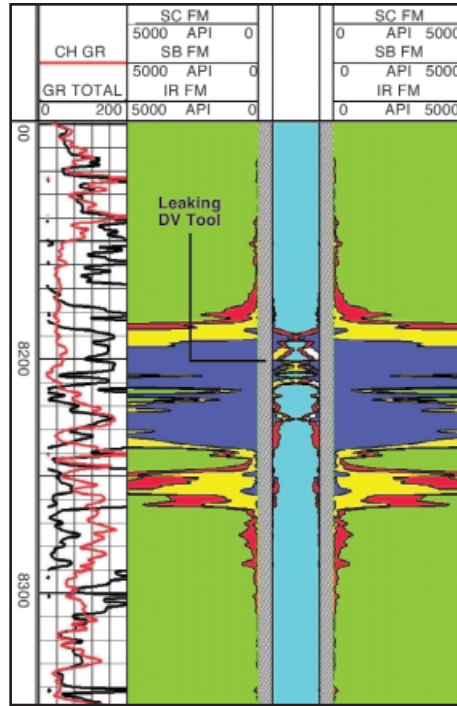
IMAGE 2

Before attempting the rigorous procedure of trying to establish where the leak was located with a packer and bridge plug operation, the operator called ProTechnics to rerun the SpectraScan Image tool from surface to 12,000'. As SpectraScan image 2 (see next page) clearly demonstrates, the stage tool at 8,204' was leaking. The strong count rates for all three tracers were conclusive evidence that the fracture treatment had exited the wellbore at this point. Additionally the presence and high count rate of all three tracers indicate that the DV tool was leaking from the beginning of the treatment and that a significant portion of the stimulation was placed out of the zone. The log across the upper DV tool at

Two squeeze cement jobs later, the leak at the DV tool was fixed and the well was placed on production. In this area, the productive deep gas zone is an over-pressured zone, and the upper zones across from the leaking DV tool are normally pressured and nonproductive. Because of this, it was determined that the deep gas zone was cross-flowing a substantial quantity of gas into the upper zones.

Always apply a radioactive tracer when fracturing past a DV tool in a casing completion. Always review the log (memory tool) over the entire wellbore, not just the zone of interest.

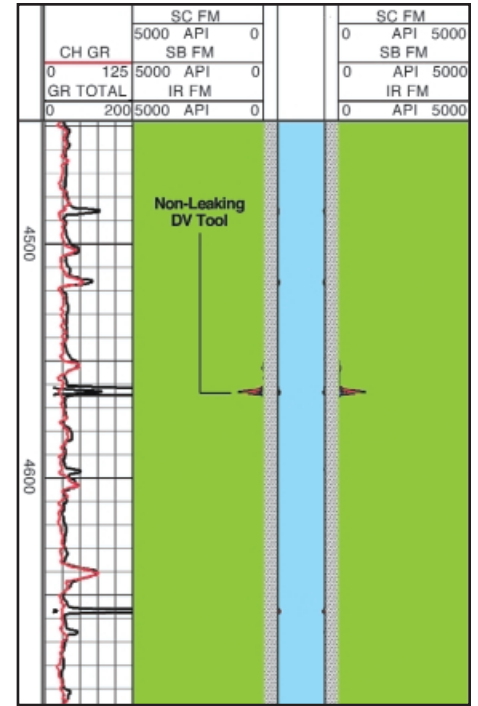
IMAGE 3

4,657', SpectraScan image 3 (see next page), did not show any significant tracer proving that it operated as designed.

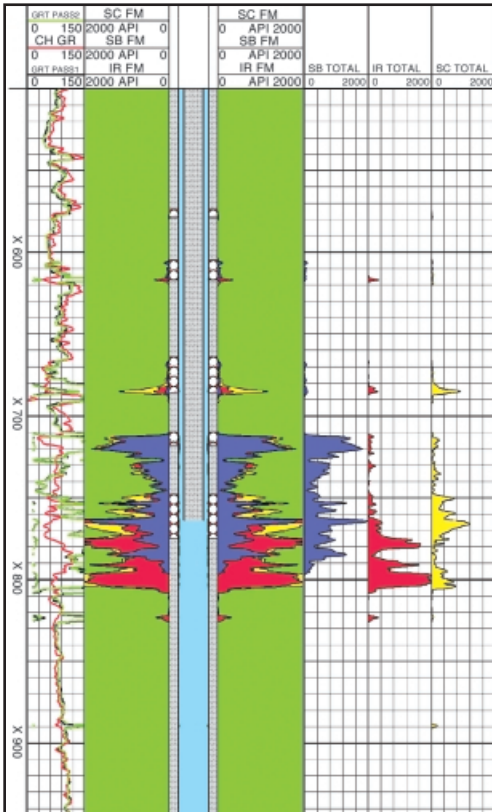
IMAGE 1 (JULY 10, 2003)

A candidate well was selected and a completion procedure was designed to fracture stimulate the entire Fruitland Coal in a single treatment. After consulting with ProTechnics engineers, a radioactive tracer injection program utilizing patented Zero Wash tracers was designed and implemented. The accompanying SpectraScan image 1 reveals that the lower two coal zones took virtually the entire treatment. The upper three coal sections were left un-stimulated.

It is very rare that two SpectraScan images from the same well with such a long time interval between each log event can be compared. Please take time to study the comparison between SpectraScan image 1 (logged July 10) and SpectraScan image 2 (logged December 16). Notice the placement of the isotopes between the July

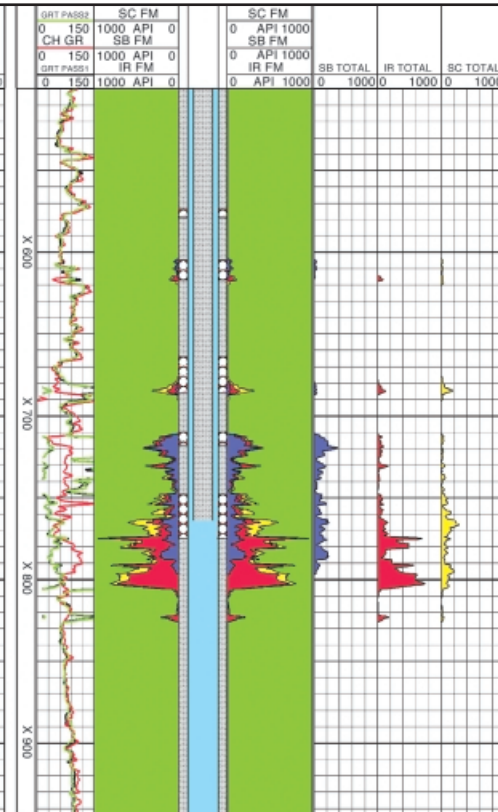
IMAGE 2 (DECEMBER 16, 2003)

image and the December image is remarkably the same. The only major difference is the count rate reduction due to half-life decay (note that the count rate scale is 0-2,000 on the June log and 0-1,000 on the December log)

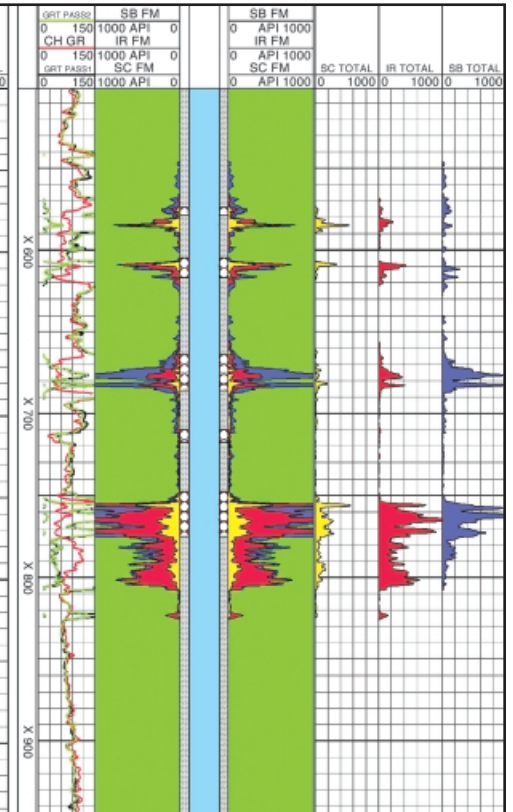
IMAGE 3 (DECEMBER 31, 2003)

A bridge plug was placed at X710' prior to re-fracing the upper three coals. Each of the three coals was broken down individually with acid. The fracture stimulation was again traced with all three isotopes. SpectraScan image 3 depicts the placement of the re-frac attempt. It is clear that the upper three coal stringers have now been adequately stimulated, as evidenced by placement of all 3 tracers at a suitable count rate in each of the coals. Notice that the tracers in the perforated interval from X710' to X740' have been removed. It is suspected that the breakdown acid treatments actually found the bad cement interface between the upper coals and lower coals, and displaced the tracers from the near wellbore area. The lowest coal from X750' to X775' also took some of the re-frac, as is evident from the increased count rates for all three tracers. It is clear that the cement problem contributed to the containment problem encountered in the re-frac attempt.
